## **Limited Visual Dam Safety Inspections**

**Ku Tree Reservoir**

**Oahu, Hawaii**

**May 2006**

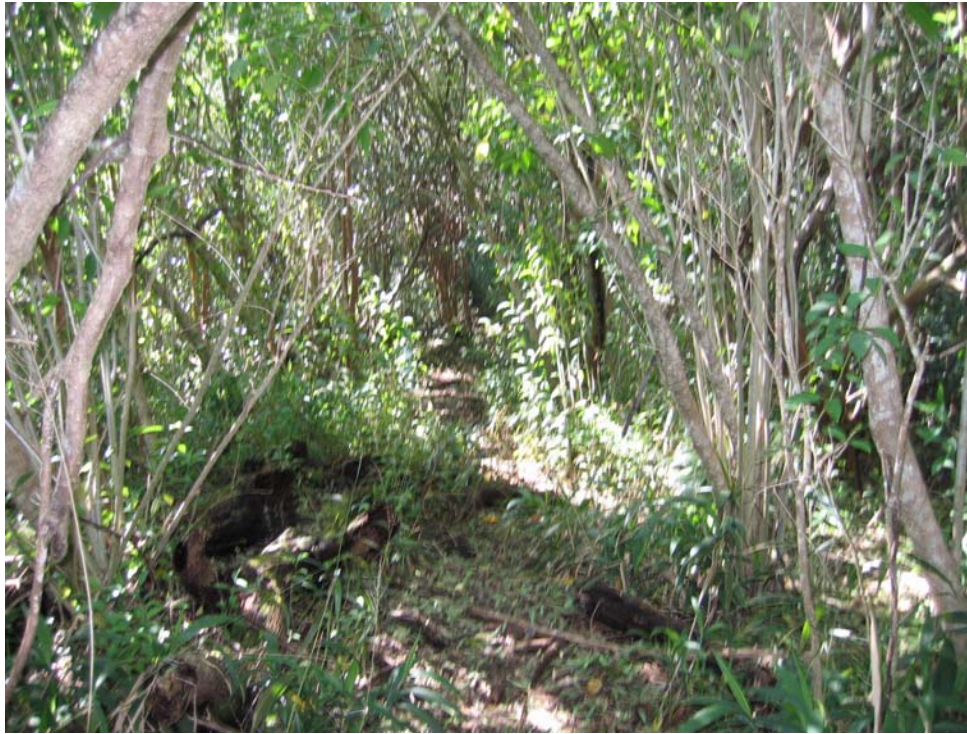
Vegetation was observed on the crest. These were primarily woody vegetation and high grass and bushes.

- e. Tree(s) were observed along the dam crest. Trees have been identified as the probable cause of piping failures, and can possibly cause severe damage to the embankment if they are uprooted during high winds. Corrective action is required to remove the tree hazards from the dam. Acceptable remedies include removal of the tree and its root structure down to a 2" diameter and reconstructing the damaged embankment section. All repair work shall be accomplished as per the requirements of licensed geotechnical or structural engineer. Routinely monitor the damaged area for signs of settlement and seepage.

**Photo 1 Crest of dam, dense vegetation.**

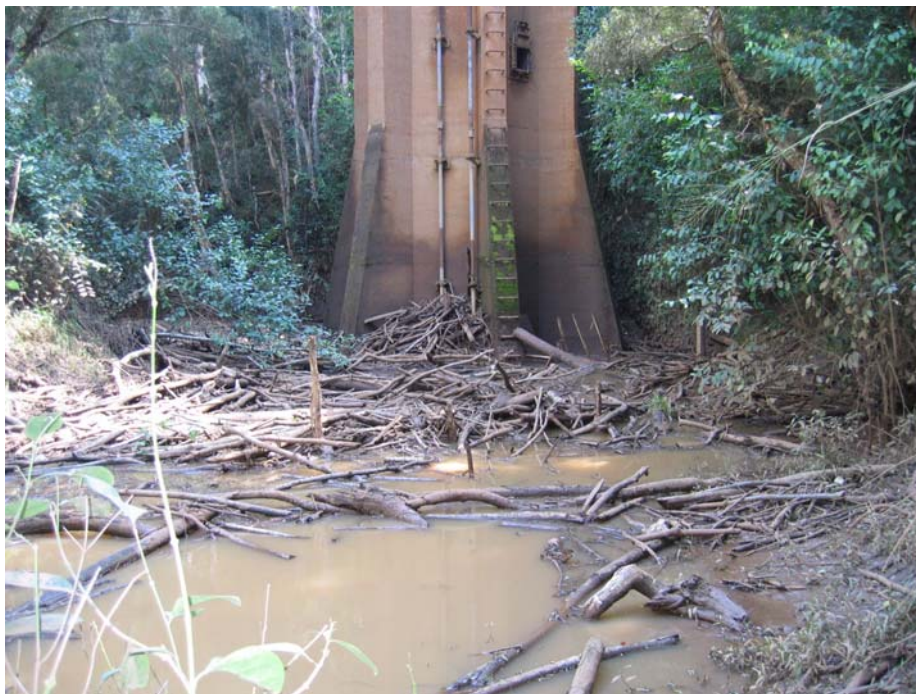
**Photo 2 Base of intake tower, woody debris.**

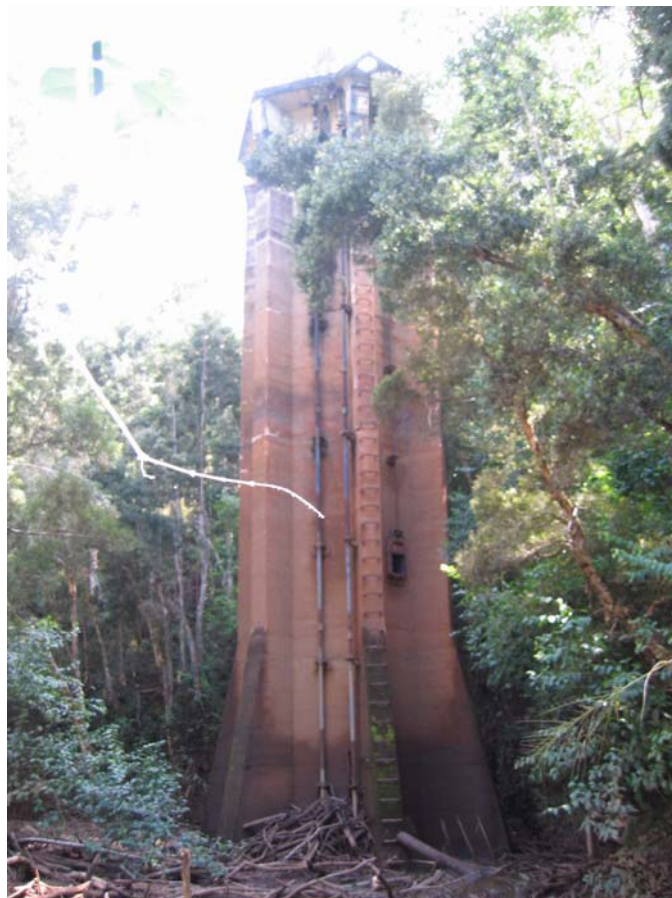
**Photo 3 Intake tower.**

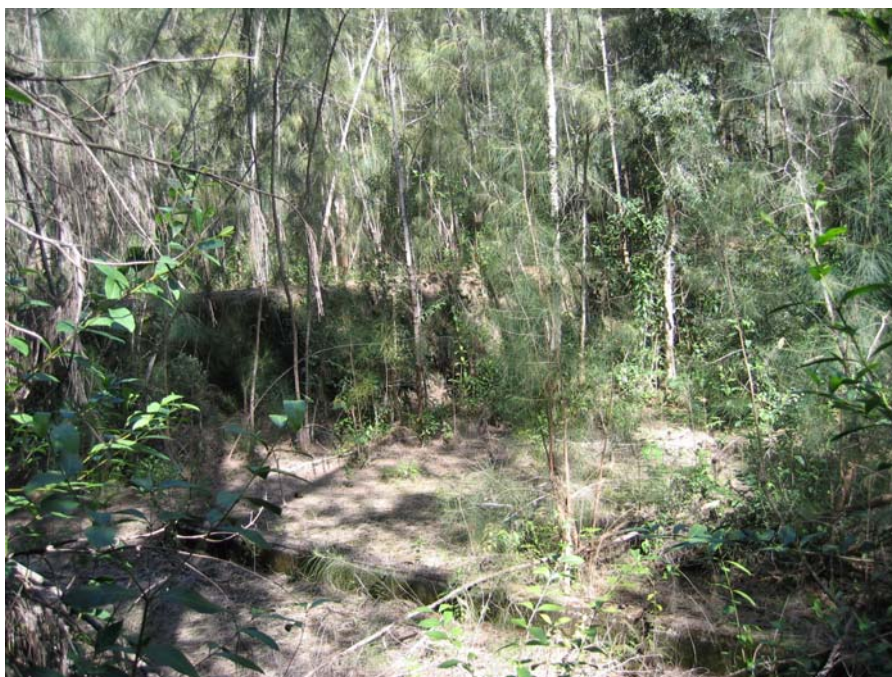
- a. The Spillway appeared to be in fair to poor condition and requires corrective action.

**Photo 4 Spillway looking upstream, vegetation.**

- b. Slope protection needs maintenance or repair. Description: Remove trees.
- c. Trees are unacceptable in the spillway channel and approach. Take corrective action to address the woody vegetation problem and repair the damaged area.
- d. Unclear if spillway is adequately sized. Spillway should pass the probable maximum flood. Verify spillway capacity and take corrective action as required.
